Various Coupon Designs

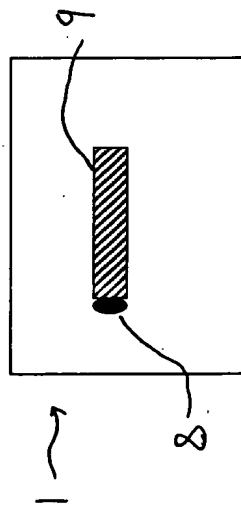
Fig 1(a). Rectangular disbondment with a holiday defect at one end

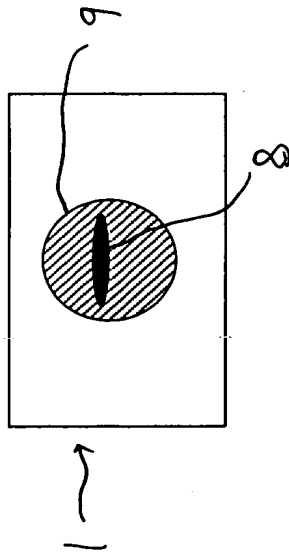
Fig. 1(b). A circular disbondment with a small gap and a crack in the middle

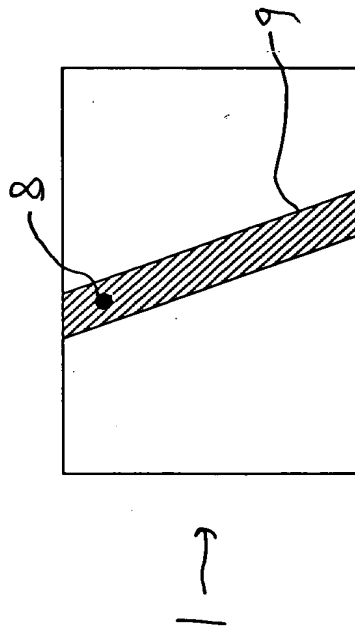
Fig 1©. Disbondment along overlap of a spirally wound tape coating and a holiday at one section

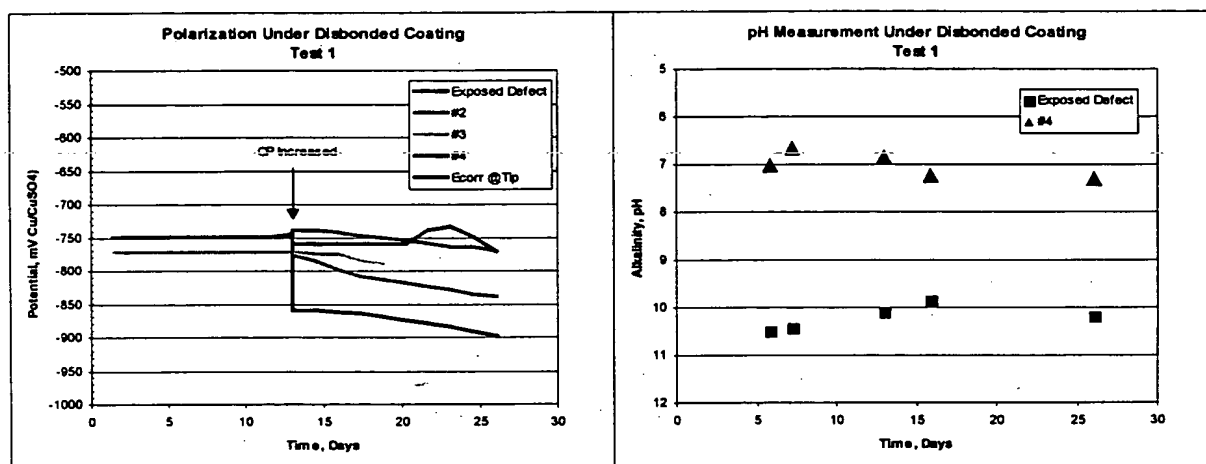
Figure 6. Test 1 polarization and pH data collected under a coating disbondment and adjacent exposed defect.

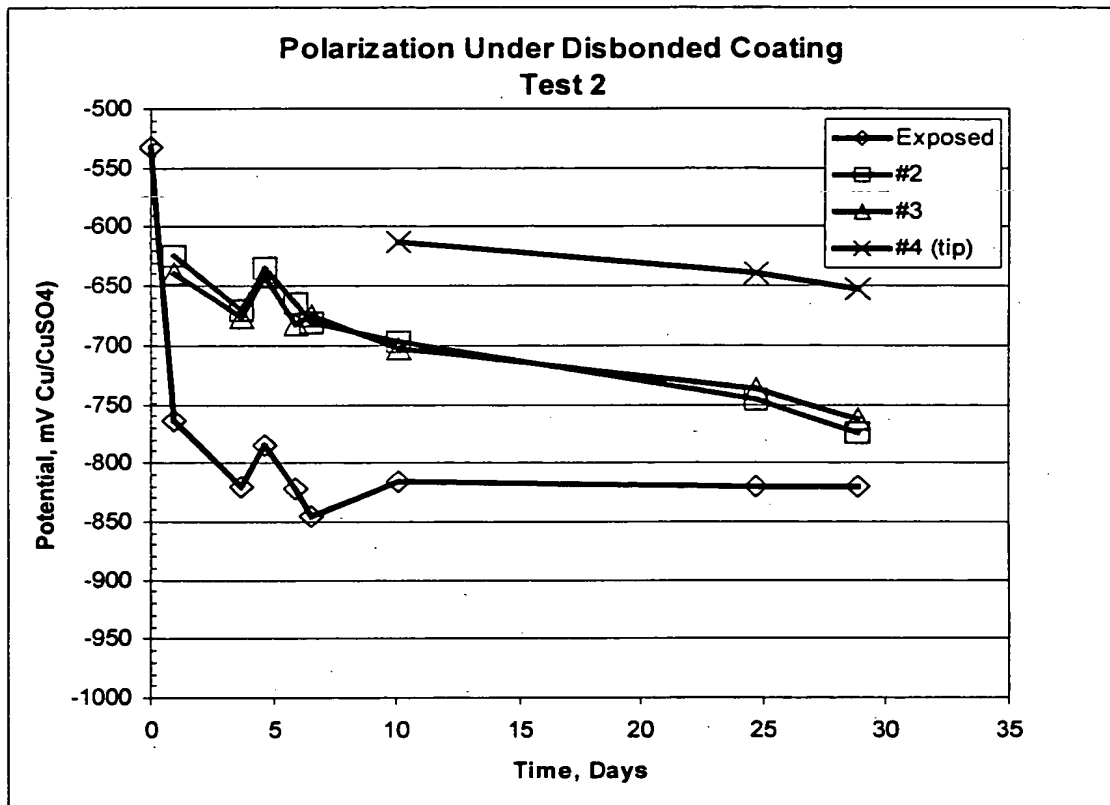
Figure 7. Test 2 polarization data collected at an exposed defect and under an adjacent coating disbondment.
